AFWAL-TR-87-2004

EFFECTS OF AIRCRAFT ENGINE BLEED AIR DUCT FAILURES ON SURROUNDING
AIRCRAFT STRUCTURE

A. M. Johnson
BOEING MILITARY AIRPLANE COMPANY
Propulsion Technology
P.O. Box 3707
Seattle, WA 98124-2207

April 1987
INTERIM for period March 1986 to May 1986

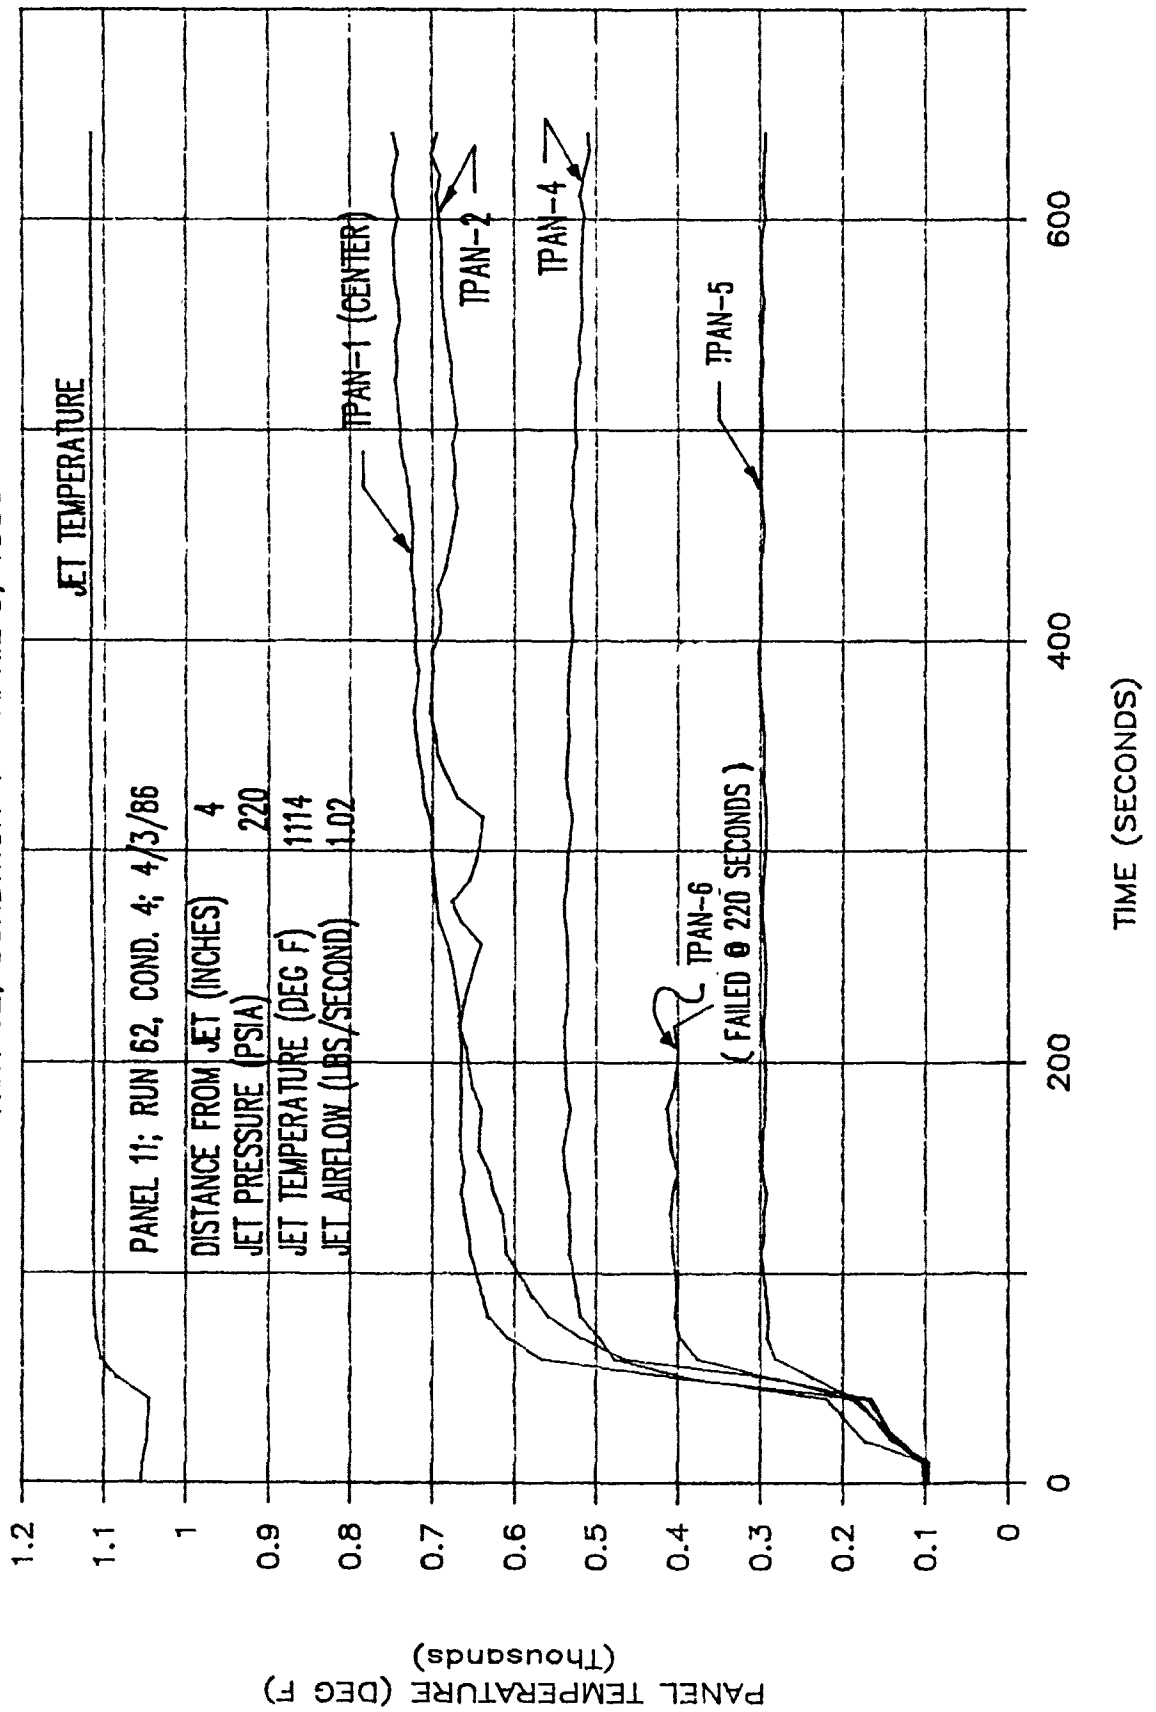
2024-T81 PANELS, 0.050" THICK

RUN 62, CONDITION 4 - APRIL 3, 1986

Figure 15. Panel Backside Temperature Variation During Ten Minute Test

The temperatures on the panel backside increased to a relatively constant maximum value during the first minute that the jet was impinging on the panel and then remained fairly constant. Generally, panel failure, when it occurred, happened within the first 12 seconds of the test. If there was no failure, the test was continued for ten minutes before concluding that the panel would not be penetrated.

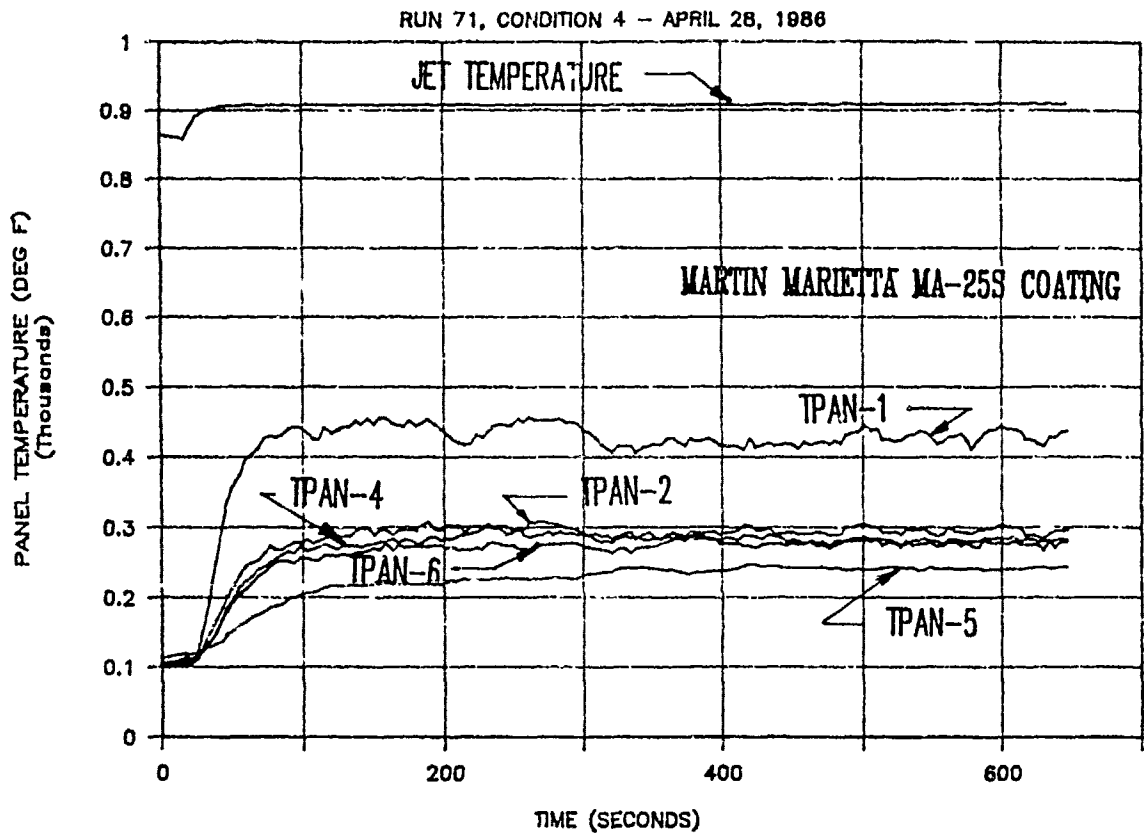
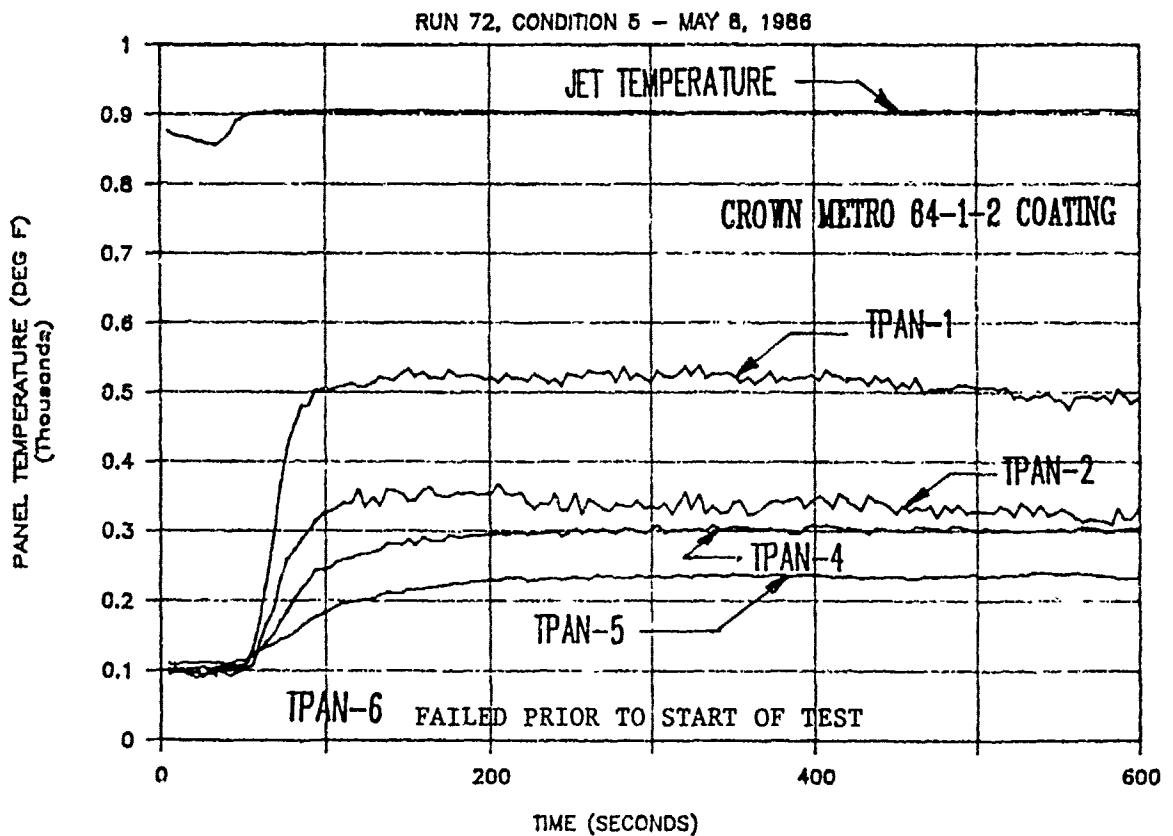
Figure 17. Comparison of Insulating Capabilities with 900 deg F Jet @ 2"

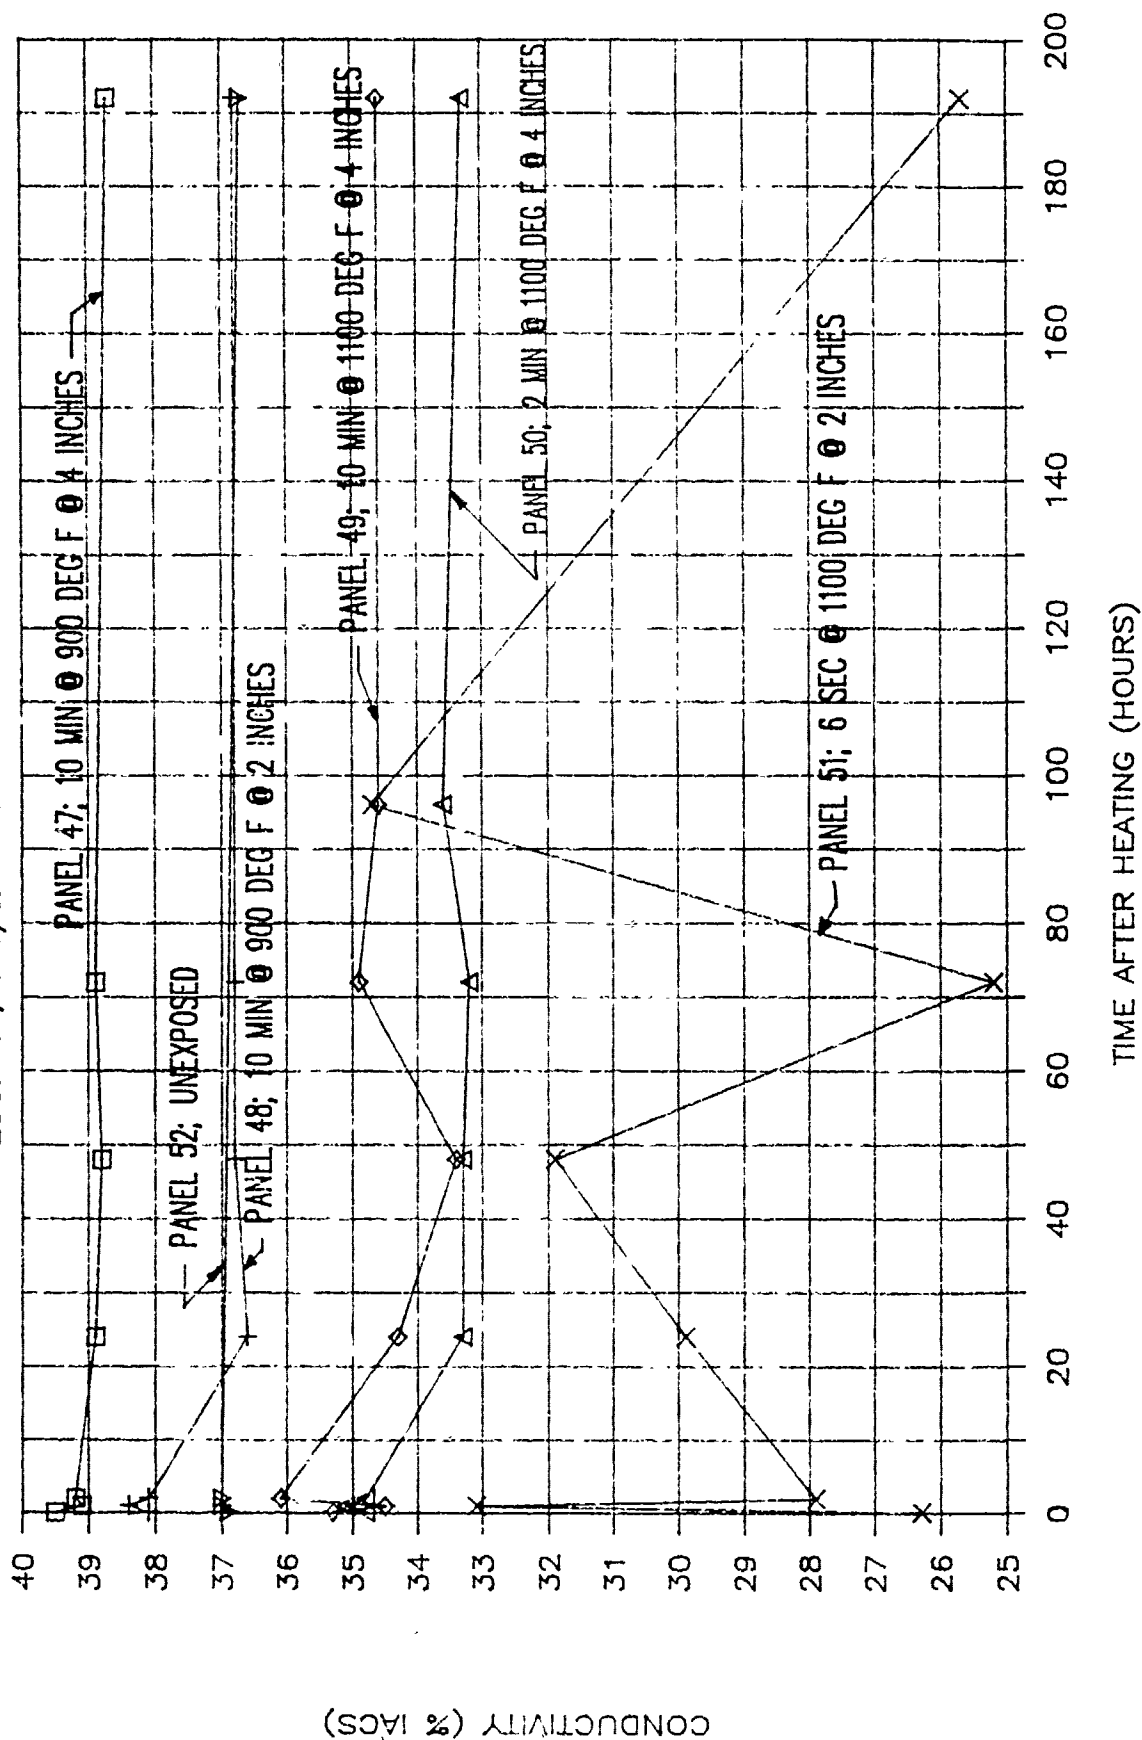
The variation in conductivity readings taken on the panel surface 1.5-inches above the panel centers over the first eight days after exposure to the hot jets was plotted (Figure 18). The erratic nature of the data for panel 51 is probably due to the surface roughness caused by exposure to the hot jet at the

location where the readings were taken, just above the hole where the jet penetrated the panel. The conductivity of panels 48 and 50 decreased about 1% in this location during the first 24 hours and then remained relatively constant during the next week while the conductivity of panel 49 decreased about 2% and then increased again to remain fairly constant at about 1% below the original level.

CONDUCTIVITY OF 2024-T81 PANELS

LOC. "T", 1 1/2" ABOVE PANEL CENTER

Figure 18. Effect of Time after Exposure on Panel Conductivity

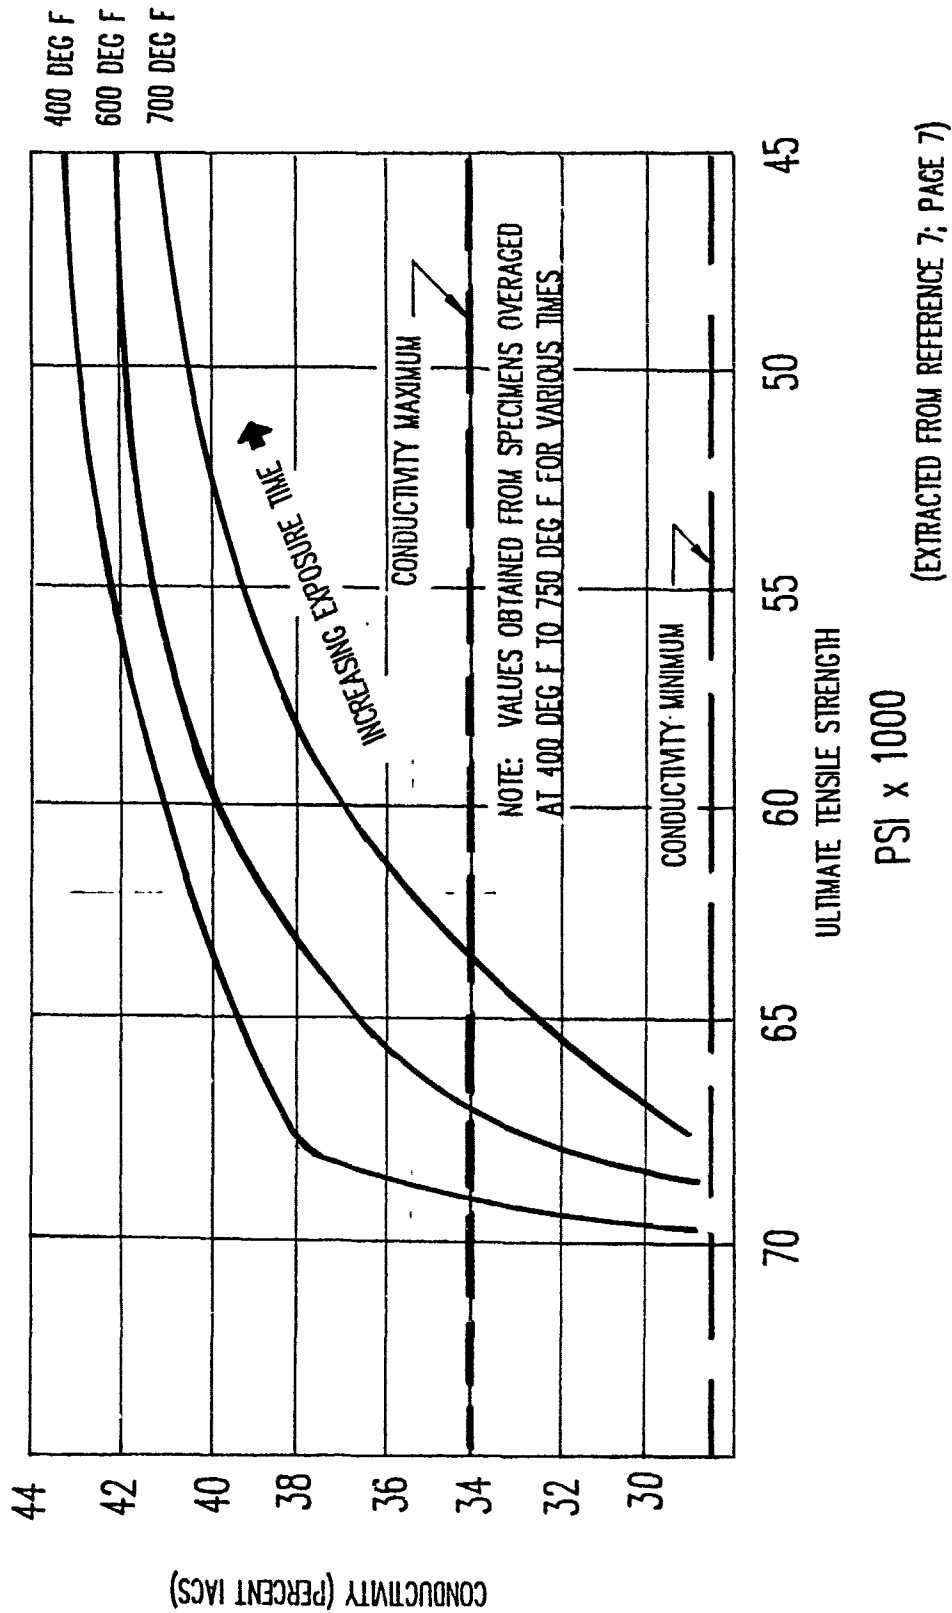
As noted in paragraph 4.4, conductivity measurements of panel 52 indicated that the material which was representative of an F-16 glove tank wall had probably been heat treated too long. Figure 22 is extracted from Reference 7 and shows the effect of excessive heat treating on 2024-T4 sheet. While the range of acceptable conductivities for this material are lower than for the T81, the effects of excessive treatment would be similar. With the T4 material, a conductivity 1.2% below the acceptable limit would imply an ultimate tensile strength from 0.4% to 1.6% higher than the specification material, depending on the temperature and exposure time. A similar increase would be expected with the T81 material.

Figure 22. Conductivity versus Tensile Strength for Overaged 2024-T4 Bare Aluminum Alloy Sheet
